CRANE STRUCTURAL REPAIR IN-SITU

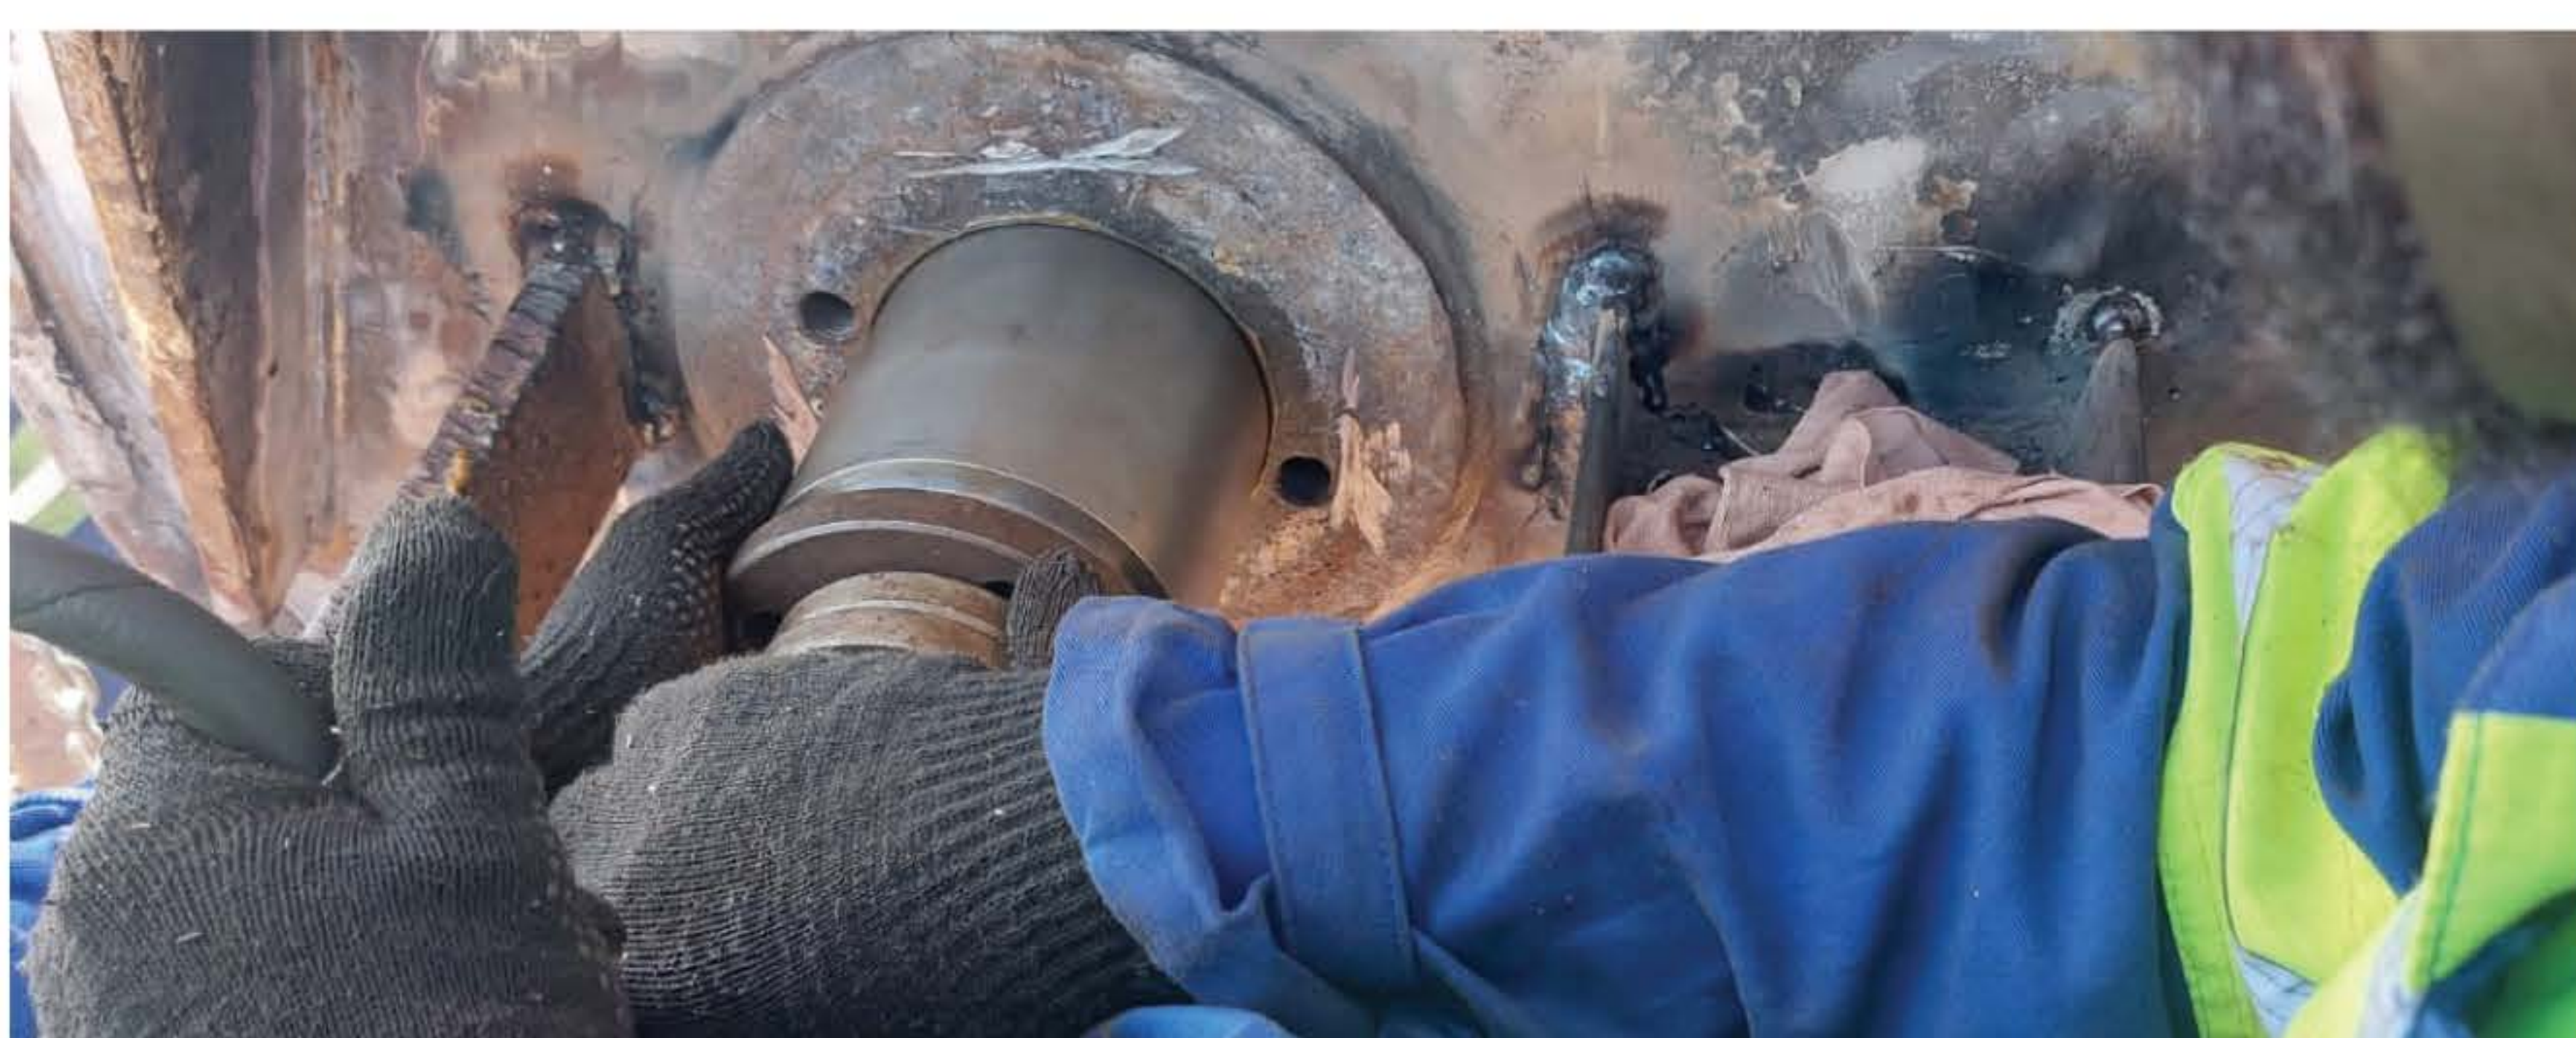
The structure of the main crane boom's pulley block was damaged, likely due to impact, causing deformation and compromising the equipment's integrity and functionality, while also posing a risk to operational safety.

1. Straightening of the crane boom structure: The structure could not be removed to the workshop as the crane was still operating with the lower capacity secondary block. Therefore, a procedure was created to resolve the problem onboard. Only the pulley and its pin were taken to the workshop for repairs as they required machining services.

6. Reinstallation and load testing: The crane structure was straightened onboard the vessel using special jigs developed by Metalock Brasil. The pulley and the new pin were reinstalled in compliance with the tolerances prescribed in the table for the bearing, model SL04 5026 PP. After installation, a load test was conducted using 35 T cap water bags, confirming the effectiveness of the maintenance.
