VESSEL PROPELLER REPAIRS

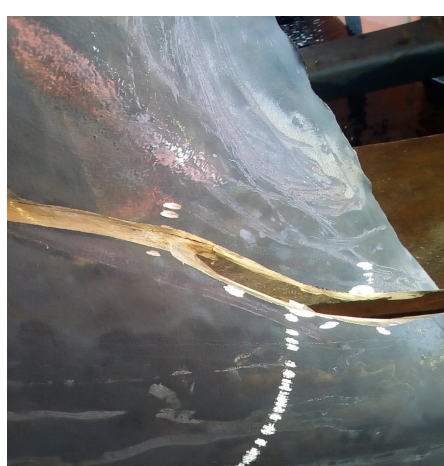
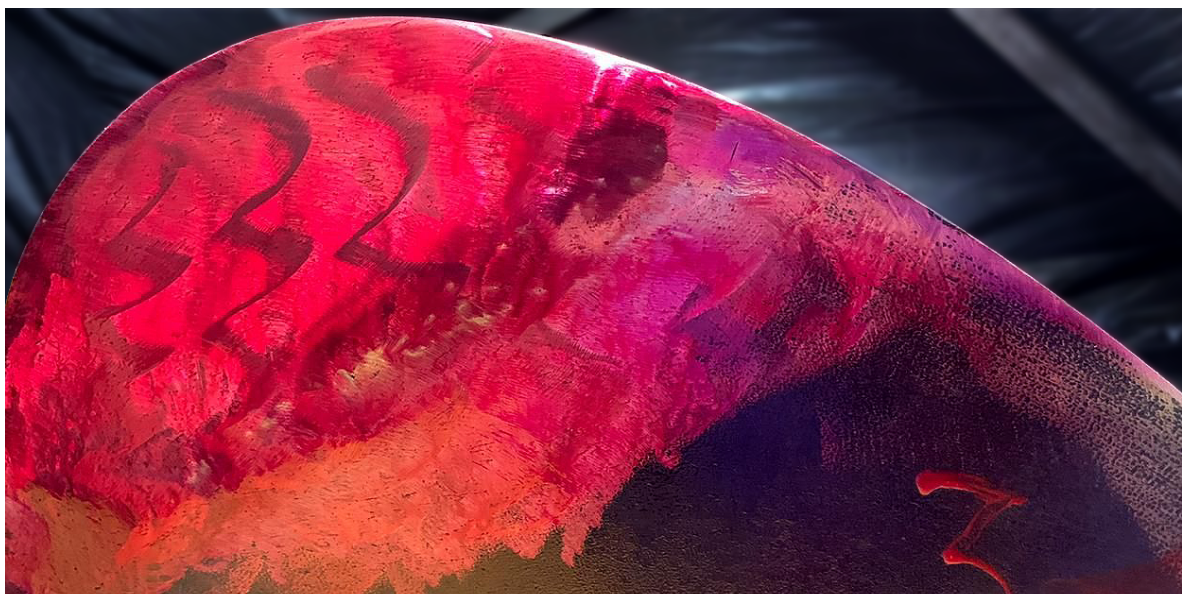
The vessel had suffered severe damage to its propeller, with some blades bent up to 90 degrees, requiring urgent repairs. Due to the issue, the vessel was navigating at a reduced speed to the anchorage area in Manaus, where the repairs would be conducted.

The conditions for maintenance were challenging, as the service had to be carried out with the vessel afloat, and only 40% of the blades were above water. Additionally, the local Amazonian climate and the unstable river conditions contributed to the complexity of the operation.

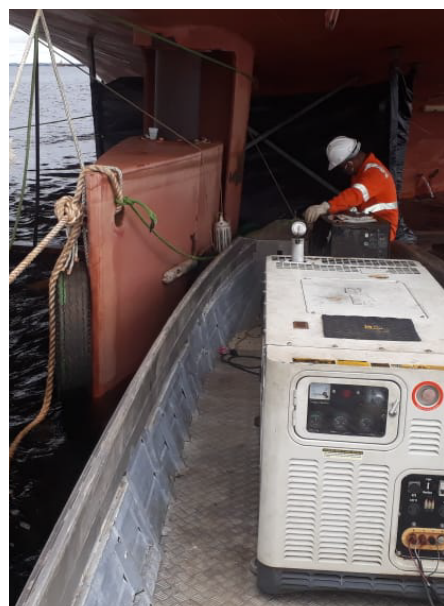
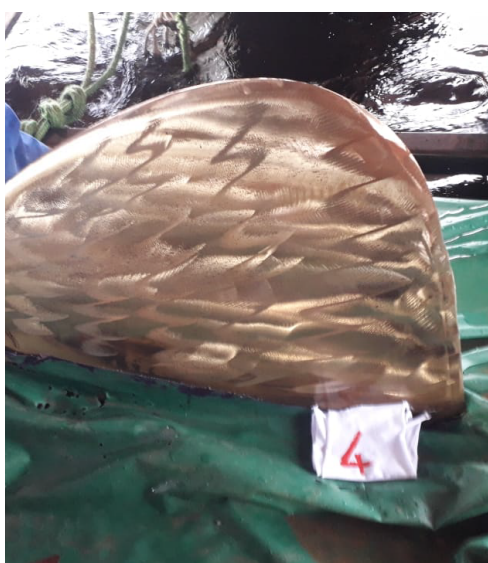
- Blades #1, #2, and #4 were successfully straightened without material loss.
- Blade #3 required the most attention, as it was bent at an angle greater than 90 degrees. During the straightening process, a crack was identified, measuring 12 mm wide and 100 mm long, which required additional procedures such as drilling stop holes to prevent the crack from propagating, followed by welding.

· Welding was carried out using specialized equipment, such as a MIG welding machine powered by a generator, since the vessel's power supply was insufficient.

· After the welding process, a rigorous inspection was conducted, supervised by an ABS (American Bureau of Shipping) inspector.

Final Adjustments: Upon completion of the repairs, all the propeller blades were stamped by the ABS, and the vessel was restored to its normal operational position. Metalock also provided instructions for jack-up tests and participated in a short sea trial.
