STRUCTURAL REPAIRS ON A LARGE CONTAINER VESSEL

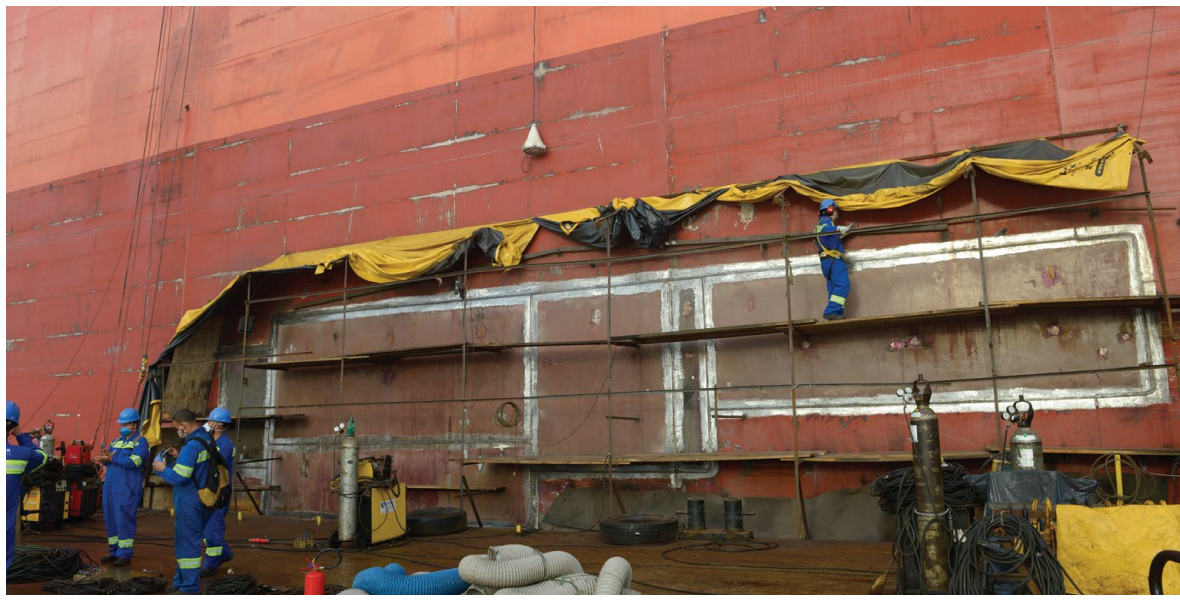
- **Engine room void:** Structures between frames 30 and 47 showed twisted and damaged hull plates, including stringers and structural frames.
- **Ballast tank #4:** Between frames 79 and 83, the hull plates and internal reinforcements were also significantly compromised.

- **Removal of damaged areas:**
Twisted and deformed parts were cut out and replaced with new sections.
- **Edge preparation:**
Edges of the parts were shaped and prepared for welding, following the Welding Procedure Specifications (WPS).
- **Specialized welding:**
SMAW and FCAW processes were used, with high-quality electrodes and consumables. All welds were made in compliance with ASME IX and DIN EN-287-1 standards.
- **Continuous inspections:**
Ultrasonic, vacuum box and penetrant tests were conducted during and after execution to ensure structural quality.
