ALTERNATOR REWIND

The client is a shipowner from Dubai, owning a vessel equipped with a 750 KVA alternator. This client operates in a highly demanding industry, relying on the operational efficiency and reliability of marine equipment.

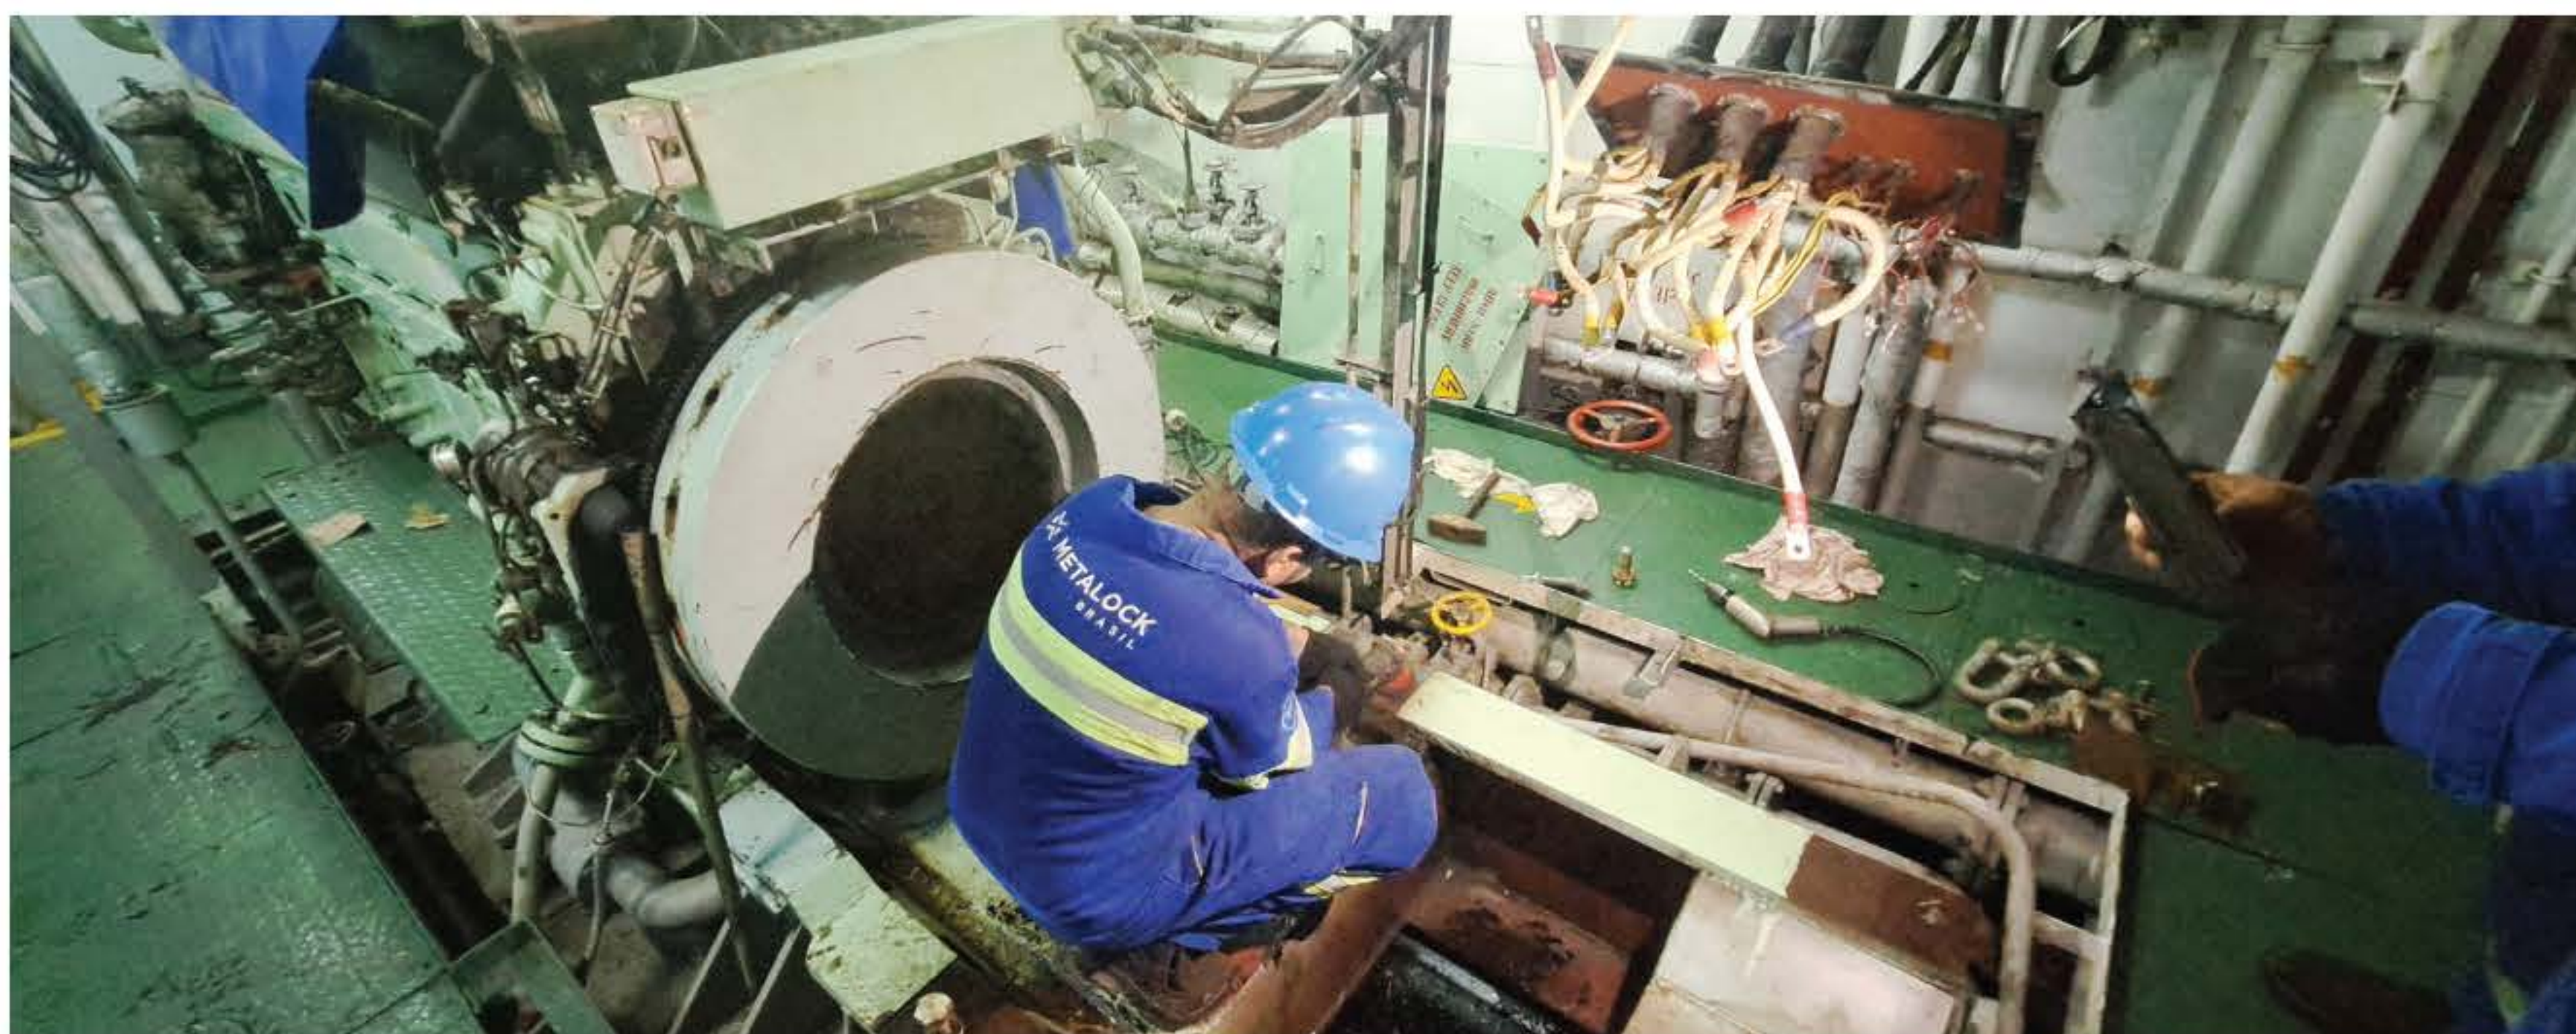
During a routine inspection, the crew identified issues with the vessel's alternator. Electrical inspections and measurements on board revealed that the alternator's winding was compromised.

- Conducted inspections and electrical measurements on board the vessel, using a Megohmmeter and Milliohmeter.
- Identified the need to rewind the main stator of the alternator.

- Dismantled the alternator assembly.
- Arranged for the removal of the alternator from the engine room to the deck of the vessel.
- Transported the alternator to Metalock Brasil's workshop in Santos, SP.

- Performed dimensional inspection of the rotor and generator covers, confirming they were within the manufacturer's tolerances.
- Conducted dynamic balancing of the rotor to ensure balanced operation.
- Performed thermal treatment and electrical measurements of diodes, main rotor winding, exciter stator winding, and exciter rotor winding.
- Application of the manufacturer's instructions, regarding tolerances and electrical design.
- Rewound the stator according to the original equipment schematics.

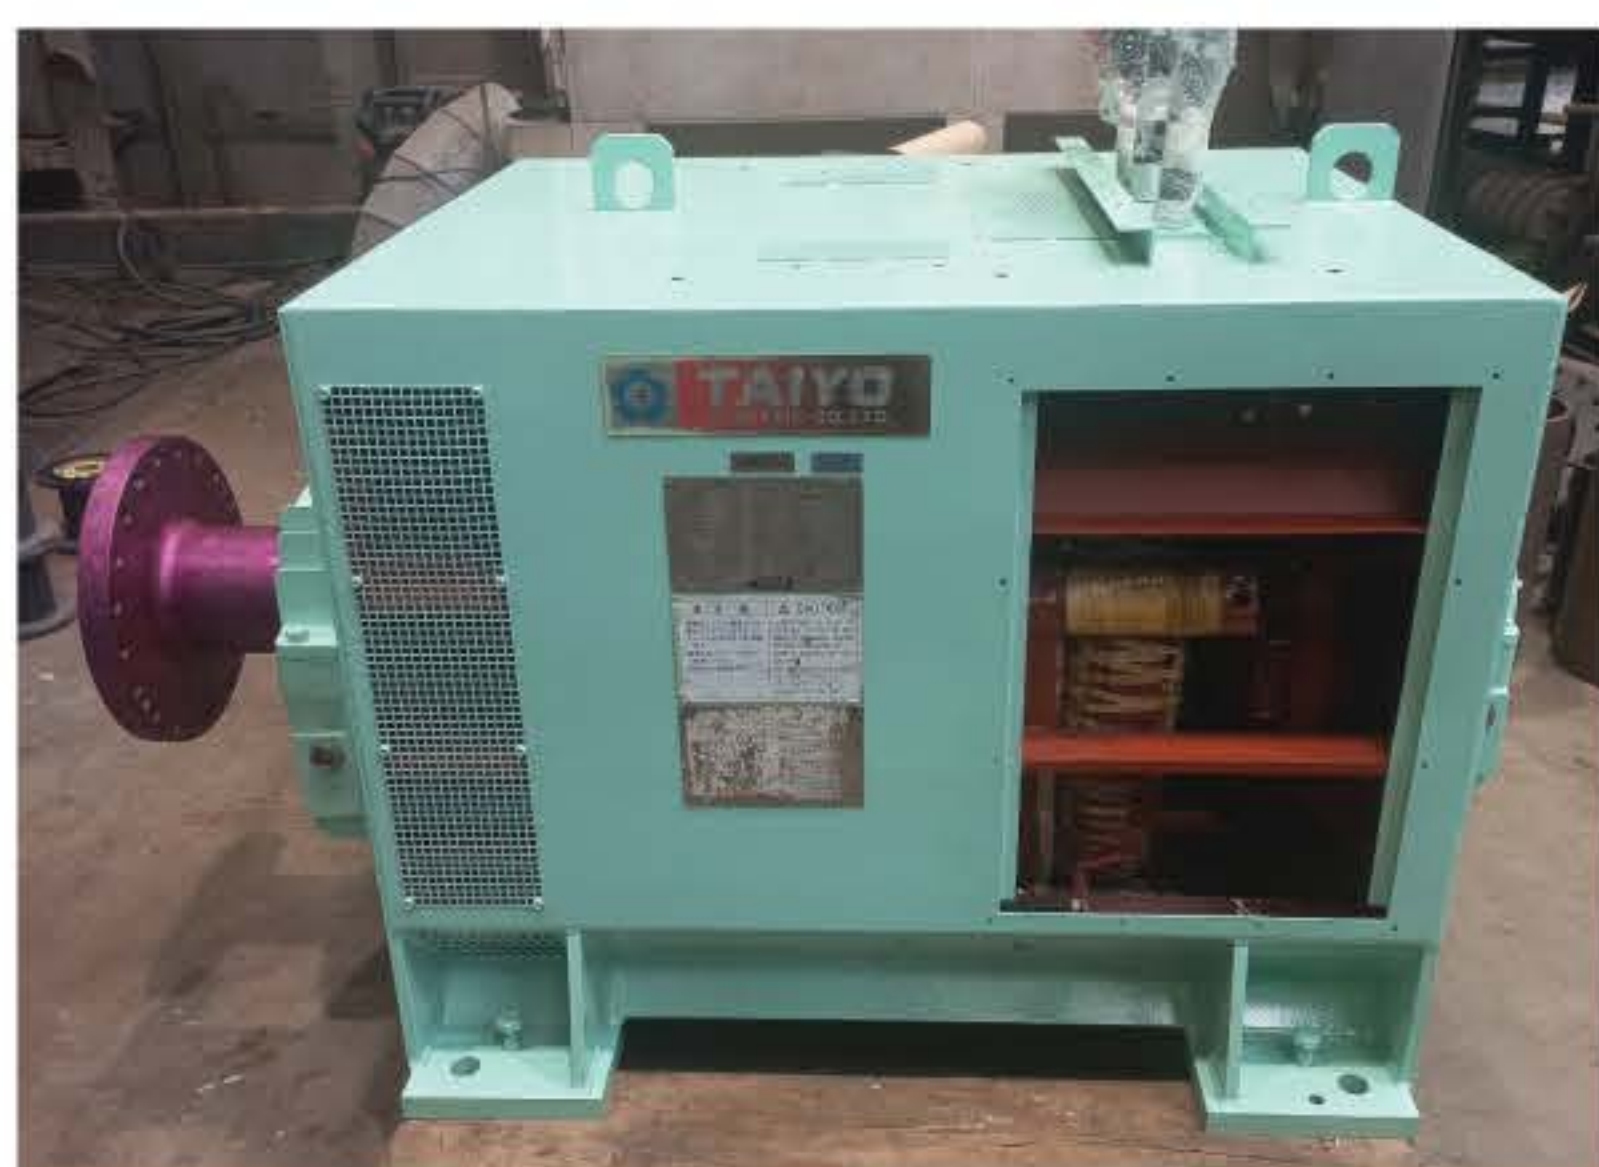
- After the vessel returned to the port of Santos, Metalock Brasil boarded again.
- Performed mechanical installation, with alternator mounted on the base, and alignment between the alternator and the engine.
- Executed the electrical connections.
- Conducted load tests on the alternator, following the manufacturer's protocol.

All tests conducted on the alternator were satisfactory and received approval from the classification society DNV.
