CRANE STRUCTURAL REPAIR IN-SITU

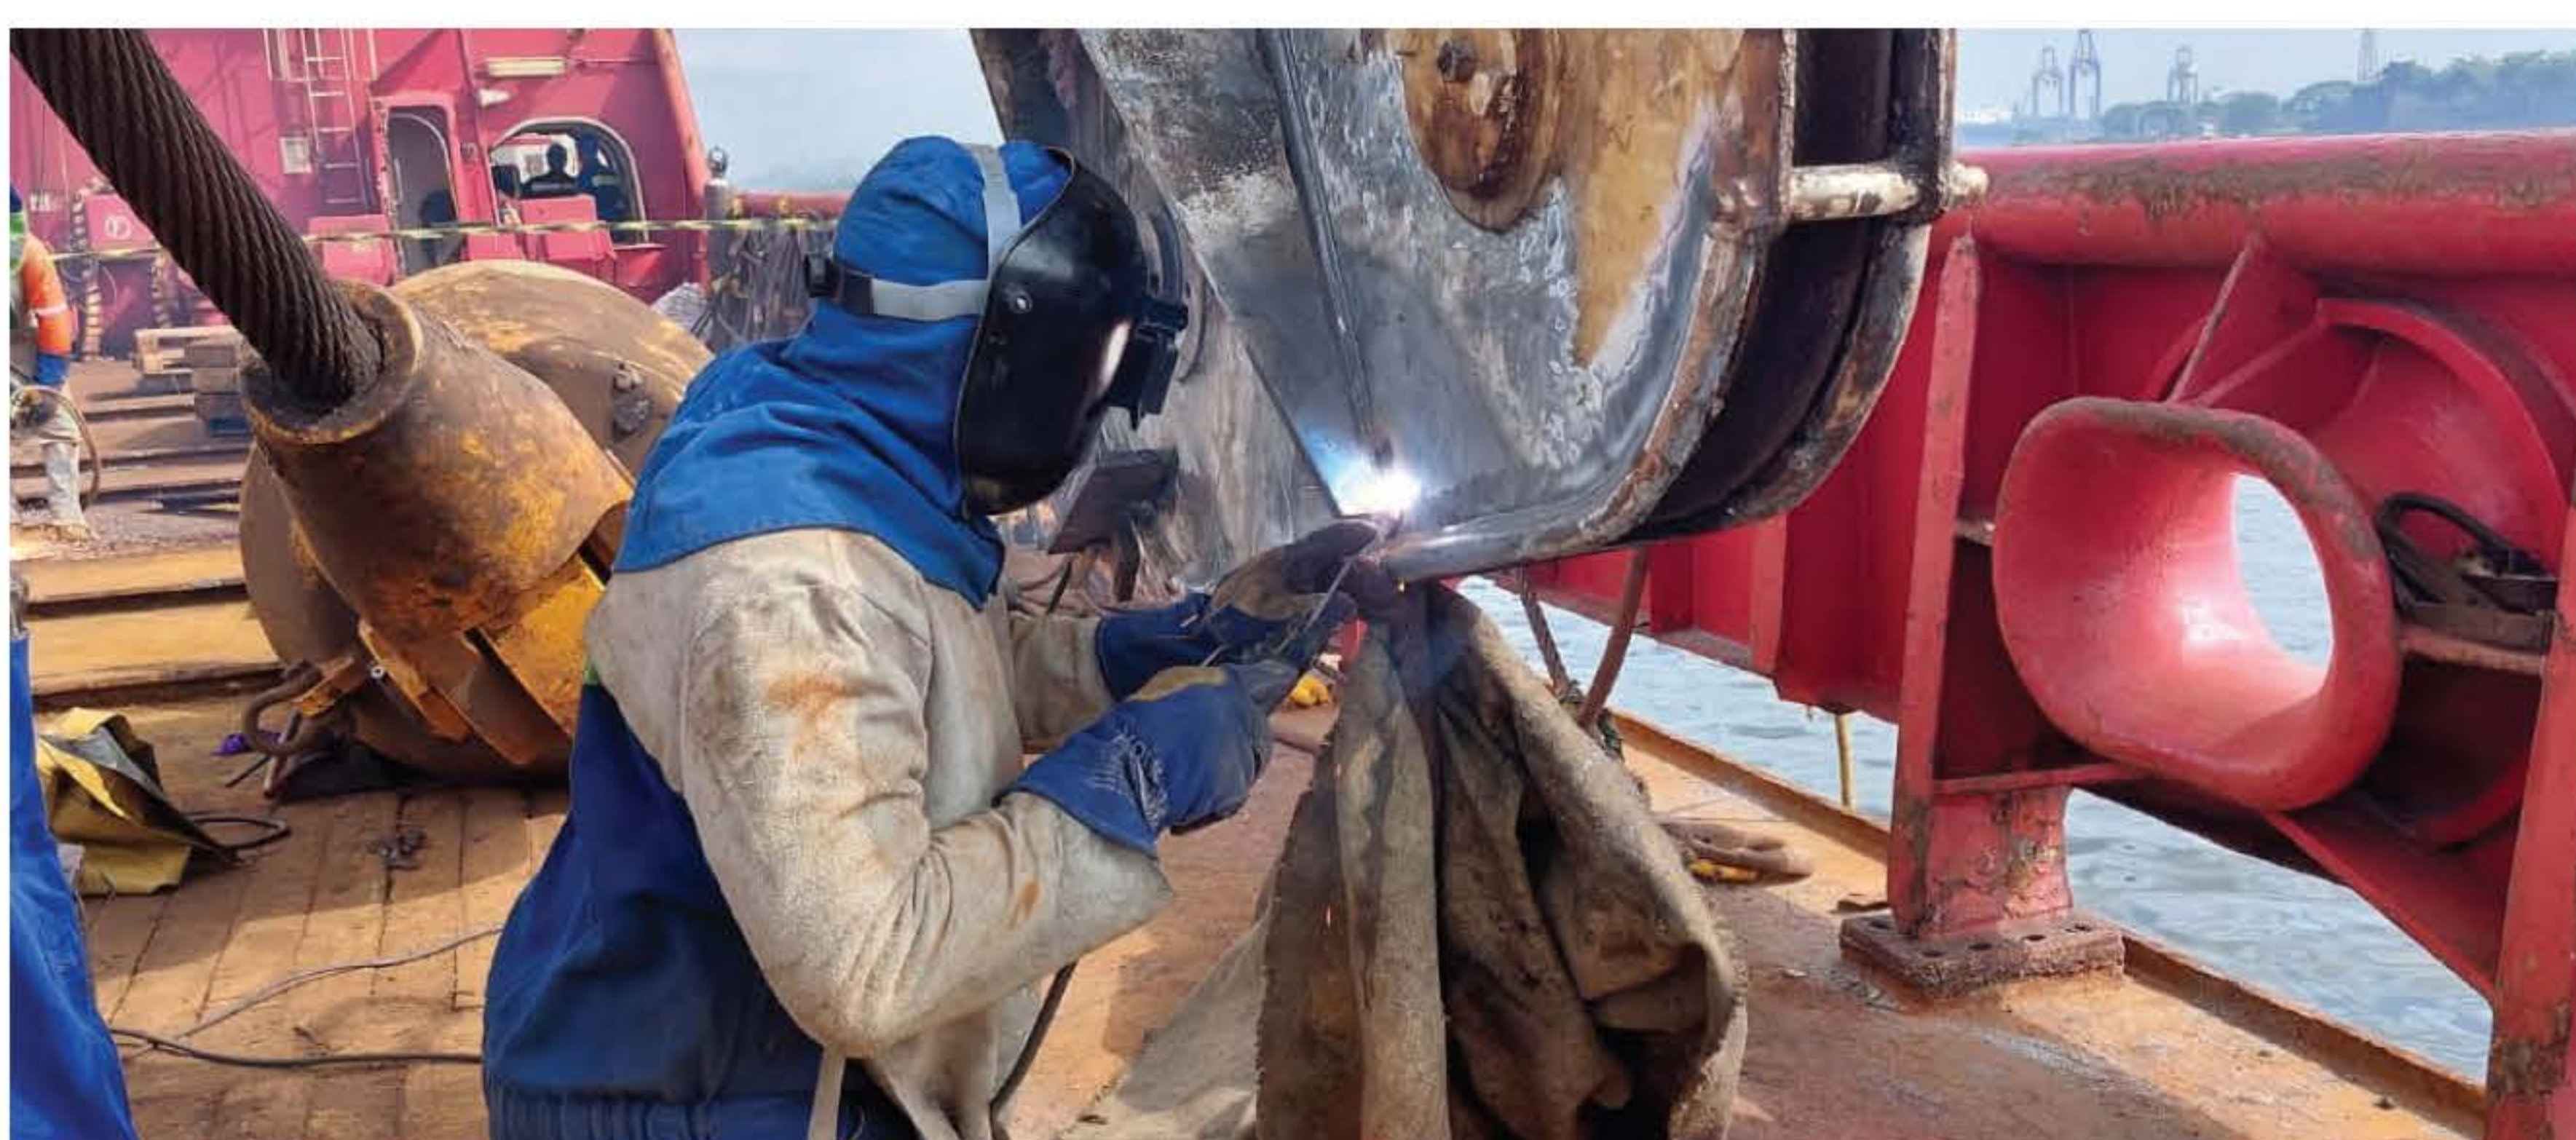
The structure of the main crane boom's pulley block was damaged, likely due to impact, causing deformation and compromising the equipment's integrity and functionality, while also posing a risk to operational safety.

1. Straightening of the crane boom structure: The structure could not be removed to the workshop as the crane was still operating with the lower capacity secondary block. Therefore, a procedure was created to resolve the problem onboard. Only the pulley and its pin were taken to the workshop for repairs as they required machining services.

2. Transport and maintenance of the pulley: The damaged pulley was transported to Metalock's workshop in Rio de Janeiro. The specialized team at Metalock began the removal of the damaged pin and the repair of the pulley.

5. Installation of new bearing: After machining, a new bearing was installed, elevating the functionality and safety standards of the equipment.
