VESSEL PROPELLER REPAIRS

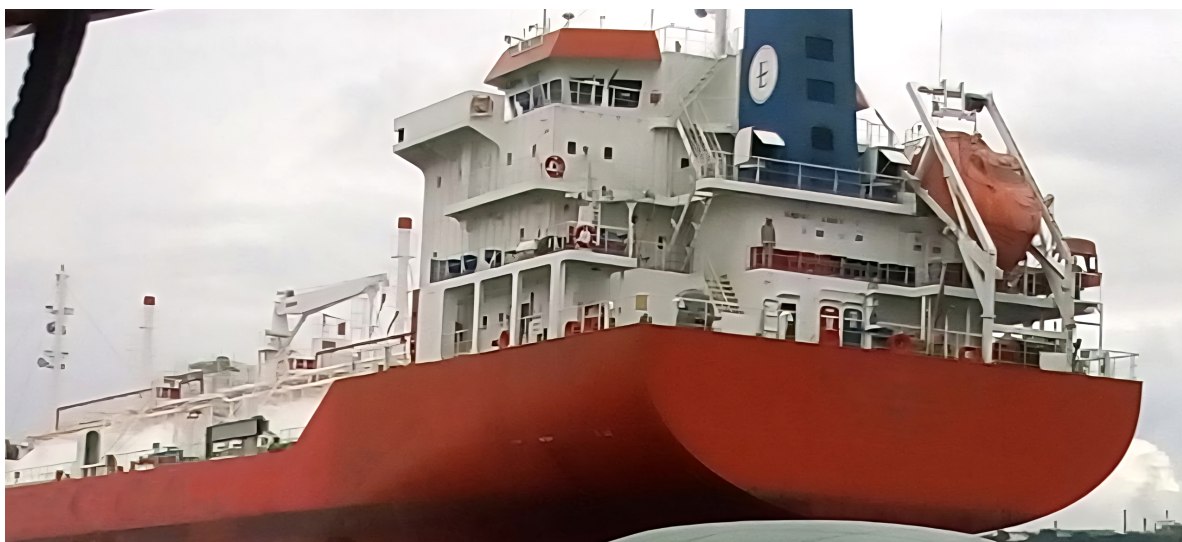
The vessel had suffered severe damage to its propeller, with some blades bent up to 90 degrees, requiring urgent repairs. Due to the issue, the vessel was navigating at a reduced speed to the anchorage area in Manaus, where the repairs would be conducted.

- Blades #1, #2, and #4 were successfully straightened without material loss.
- Blade #3 required the most attention, as it was bent at an angle greater than 90 degrees. During the straightening process, a crack was identified, measuring 12 mm wide and 100 mm long, which required additional procedures such as drilling stop holes to prevent the crack from propagating, followed by welding.
