MECHANICAL MARINE DIESEL ENGINE REPAIR: PORT SIDE MAIN ENGINE & REDUCTION GEAR

The ship is a Platform Supply Vessel built in 1999 with two Caterpillar 3606 main engines (4640BHP; LOA 66m; DWT 2800mt). The vessel is classified by ABS.

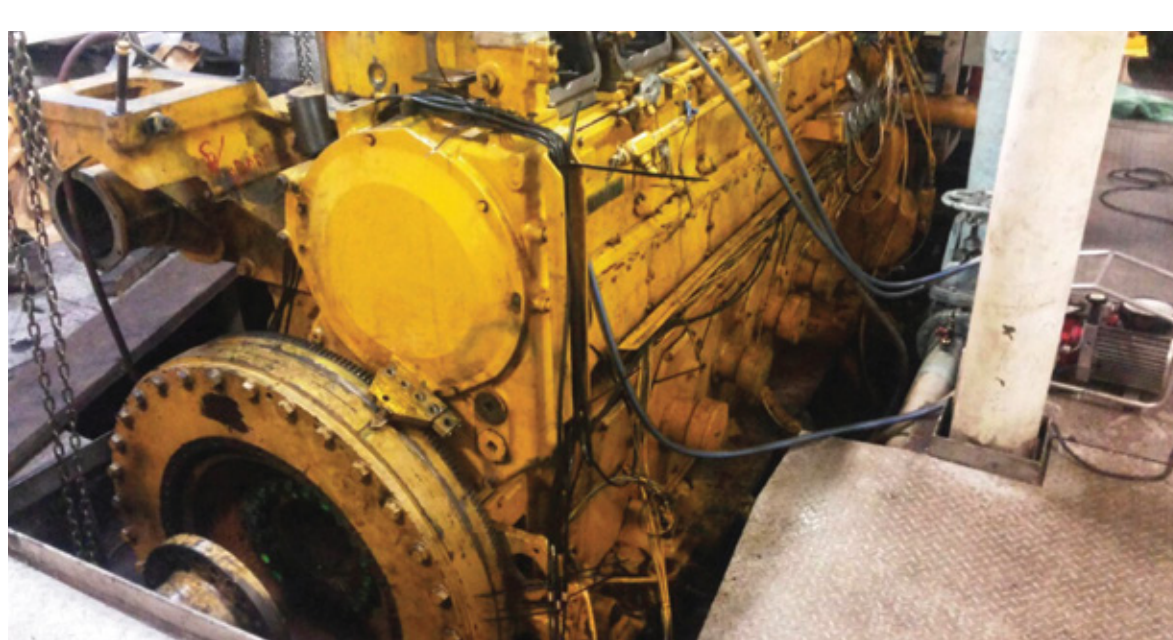
The Port Side Main Engine was shut down due to overspeed.

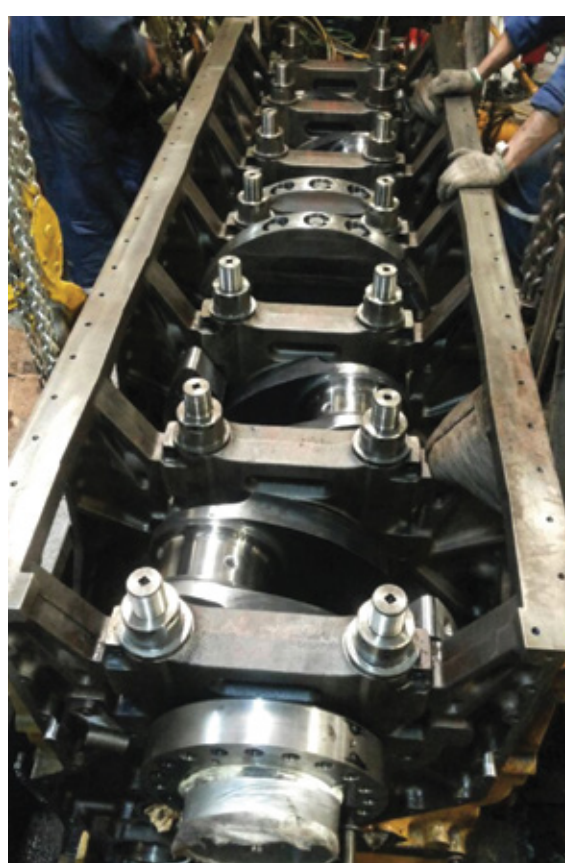
Metalock Brasil Ltda. was contracted to prepare portable equipment and to attend on board the vessel at Rio de Janeiro anchorage with specialist In Situ Machining, mechanical and alignment Service Teams to carry out inspections and necessary repair services on Port Side Main Engine:

1. Inspect main journal pockets, including all dimensional checks before and after line boring, according to the maker's tolerance tables. Having found scratches and white metal deposited on crankpins and main' journals, the crankshaft was dismantled and measurements taken. Crankpin diameter measurements varied from 214,97mm to 215,98mm. Hardness measurements varied from 45,4 HS to 73,8 HS. Main Bearing pockets before machining varied between 264,80mm and 265,08mm. Two Main Bearing Pockets were machined with Metalock's Line Boring Machine and measured at 265,98mm. Having established the amount of material to be removed from crankpins, in excess of makers allowance specification, it was decided to scrap the crankshaft and fit a new one. At the client's request, the new crankshaft was inspected and crankpin and main journal dimensional and hardness measurements were taken and reported by Metalock technicians.
